ALL TURBOCHARGER TYPES

ISSUE PREMATURE TURBOCHARGER FAILURES

LUBRICANT STARVATION > FRICTIONS, OVERHEATING > SEIZURE

COMMON TURBO LUBRICATION FAILURES

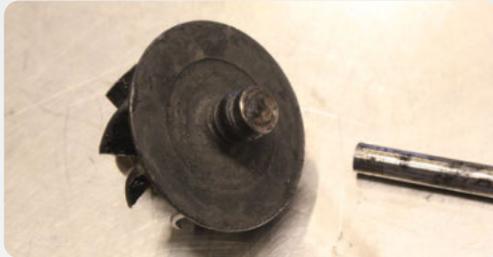
Insufficient lubrication: Broken shaft caused by lack of lubrication. The high rotation speed and frictions within the moving parts have caused the temperature to increase extremely, the shaft to warm up, and ultimately break by seizing.

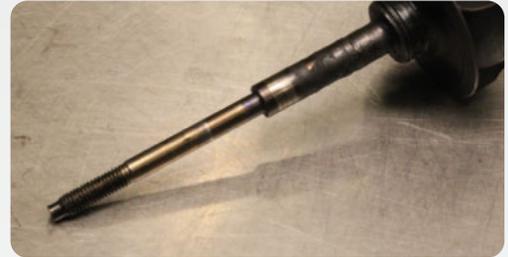
Insufficient lubrication: The surface of the turbo shaft is black and carbonized. Insufficient oil supply have caused overheating at first, thus making the steel color change. The blueish-to-yellowish color temperature is a heat tint caused by overheating of the shaft steel. Next, the remaining oil will start coking on the surface, making the black sinters.

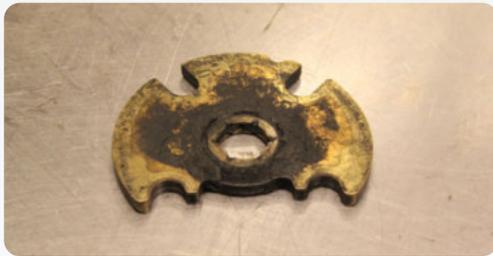
Insufficient lubrication: Oil coking on the thrust bearing – failure provoked by insufficient lubrication that caused overheating.

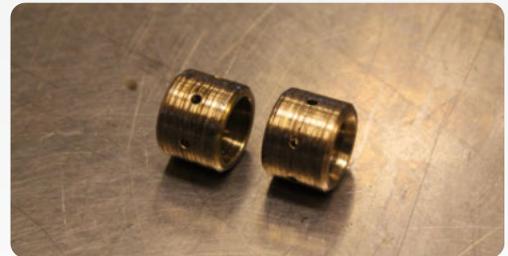
Oil contamination: The clearly visible grooves on the journal bearing surface arise from frictions and excessive material abrasion provoked by impurities in the oil. Despite the presence of oil, shaft of this turbo get seized.

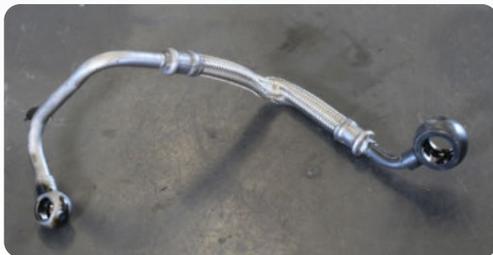
Oil supply disturbance: Oil feedline deformation caused by careless installation. The line is tight but the deformation caused oil thus shortages in lubricant supply to the turbo.

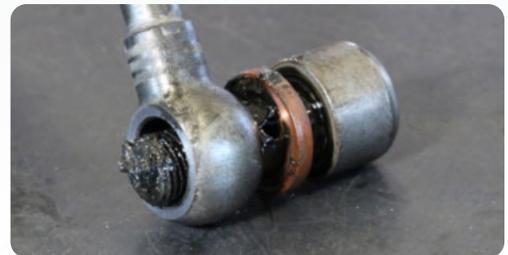
Oil supply disturbance: Severe oil contamination (sludge/ carbonizing) caused oil feed line restrictions visible on banjo fitting.
